## TEST REPORT

**Lucideon Reference:** 1873 (QT-49113/1/RK)/Ref. 1/Supp1

**Project Title:** Accelerated Weathering Testing of Ibstock Brick Ltd.'s Mechslip Brick Slip System

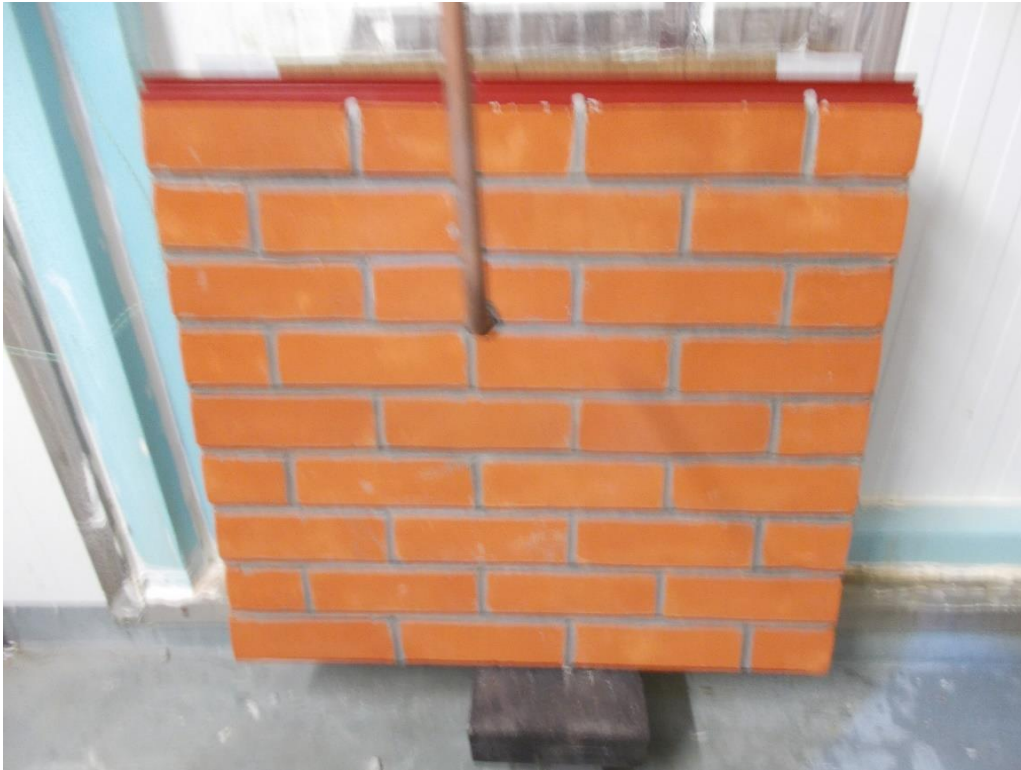
**Plate 1** – Panel Prior to Testing

Ibstock Brick Ltd supplied 1 No. panel of nominal dimensions 750 mm x 670 mm (W X H) with their Mechslip brick slip system pre-installed.

The sample consisted of clay brick slips with a slotted detailing on their rear. These were slotted onto horizontal aluminium rails at nominally 75 mm centres. The horizontal rails were themselves fixed onto vertical aluminium T rails set at 570 mm centres. The brick slips were pointed in.

A photograph of the sample prior to testing can be seen in the Plates Section.

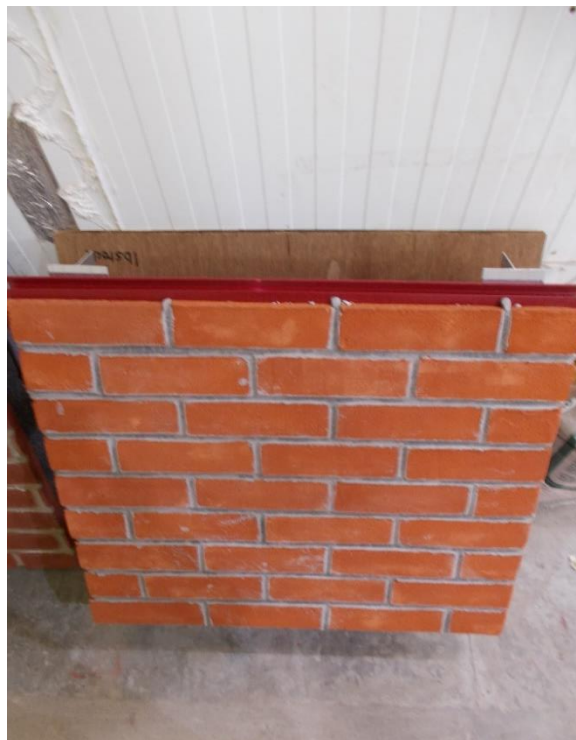
**Plate 2** – Panel following Testing

No deterioration to the sample was noted following the testing hence the Ibstock Mechslip brick slip cladding panel is deemed to have passed the hygrothermal aging test.
